# Scanner vs. Digitizer Images

VIDAR Dental Film Digitizer

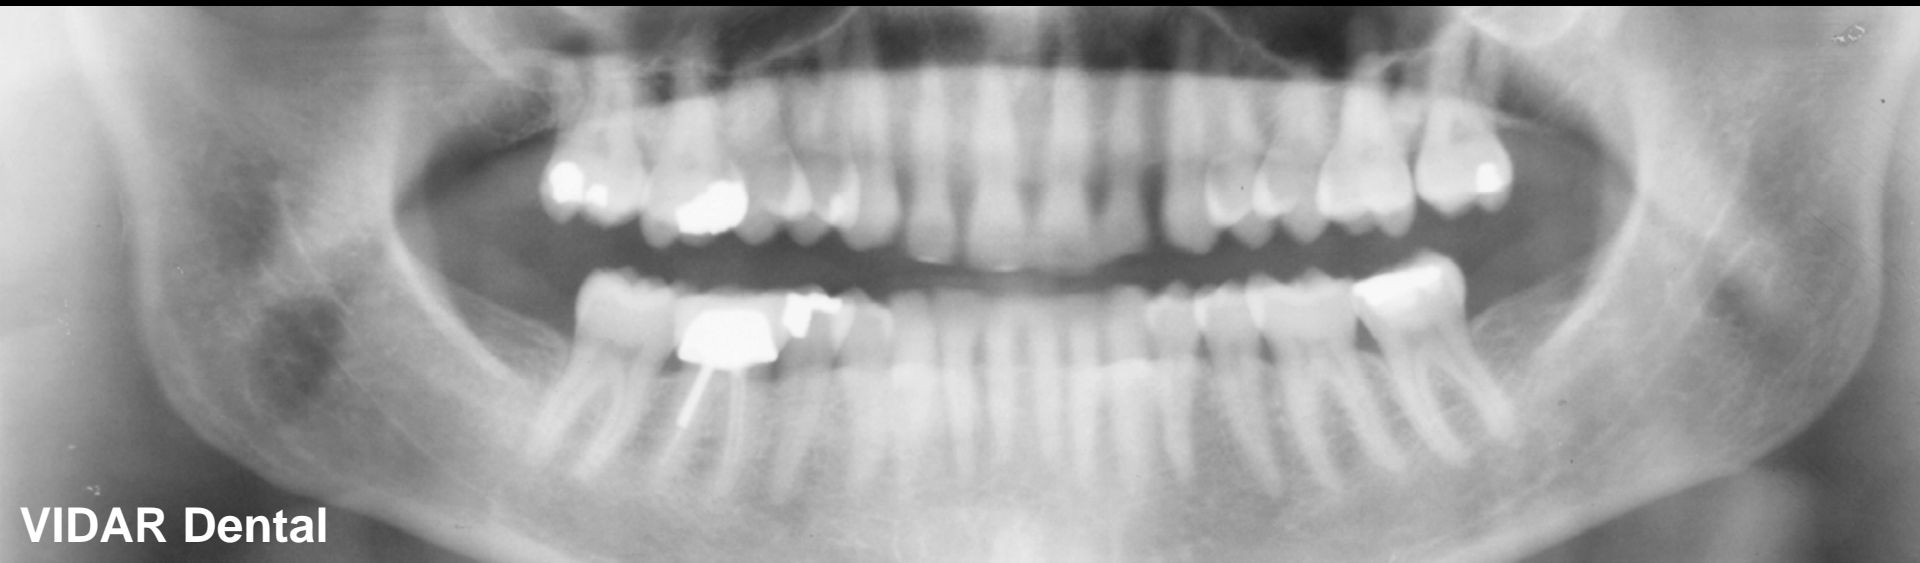
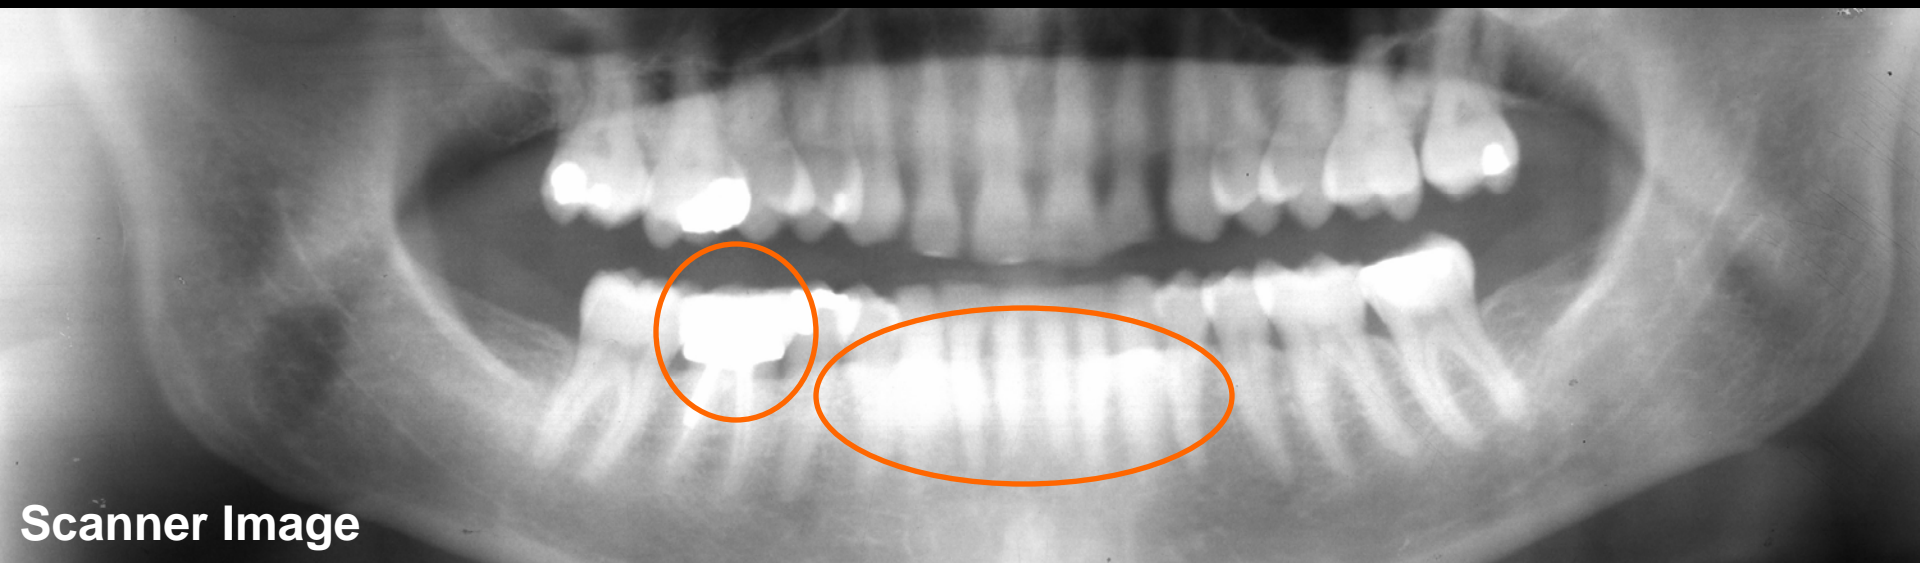
Photo on Lightbox

In the scanner image the coping and crown are indiscernible; anterior mandibular teeth roots are washed out. Lose detail in lighter areas.

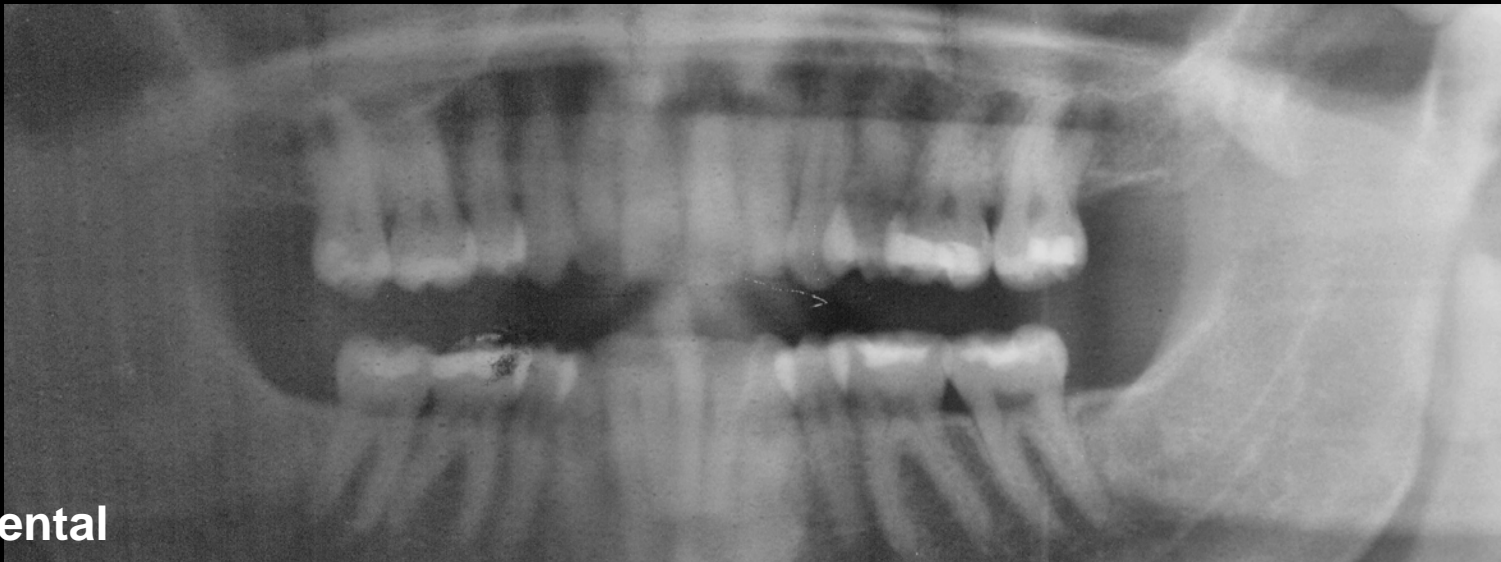
**VIDAR Dental**

Diagnostic quality up to 3.6 out of 4.1 optical density.

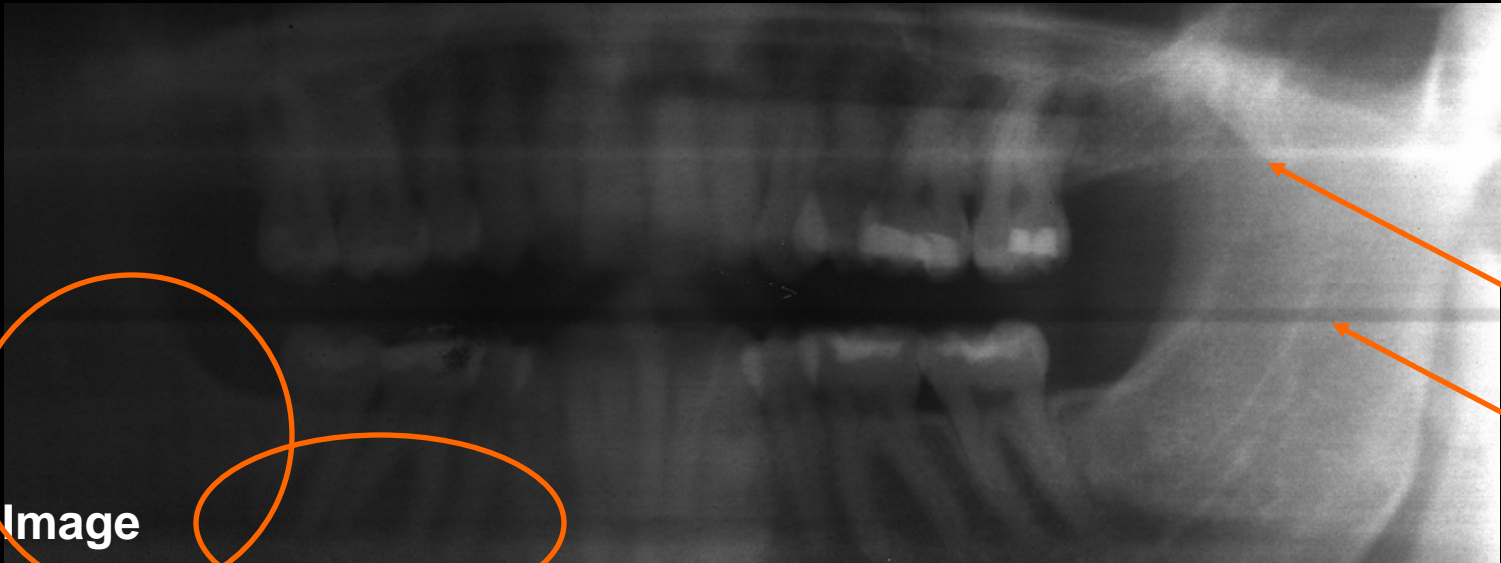
**Scanner Image**

Lose detail in darker areas.

Scanner created streaks in image.

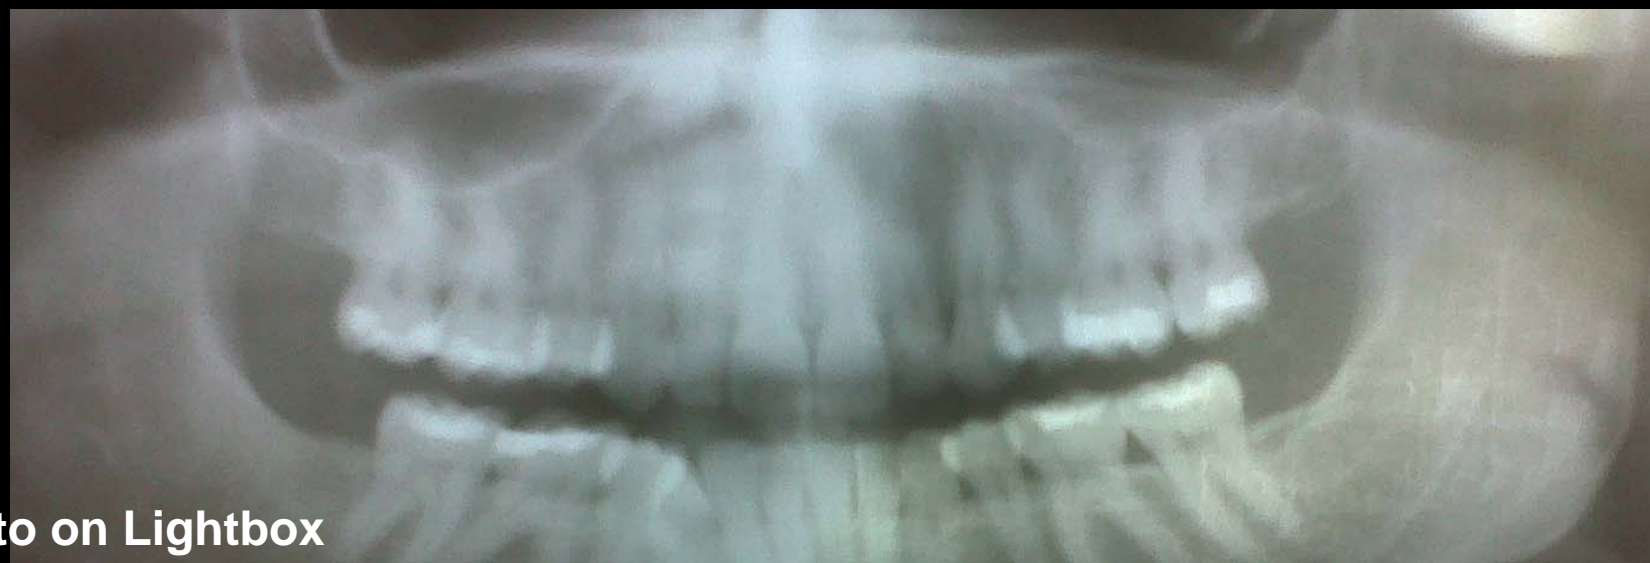
**Scanner Image**

Scanner can't capture higher densities.

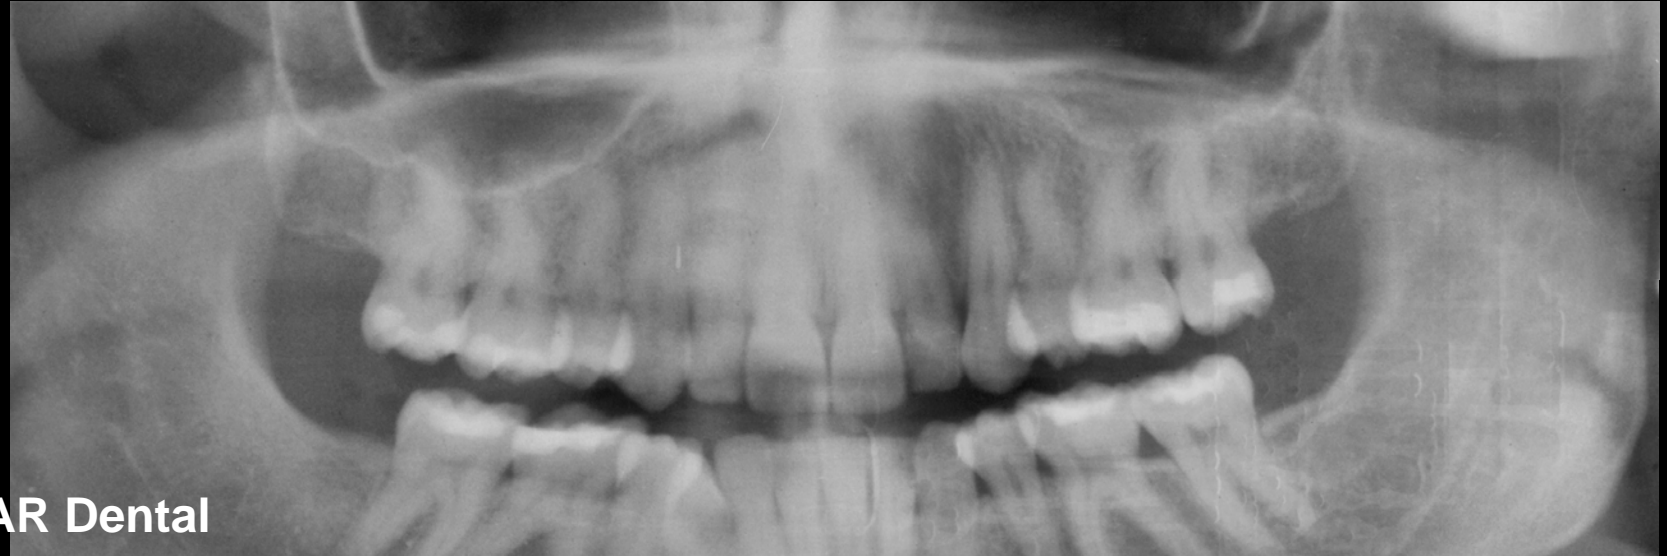
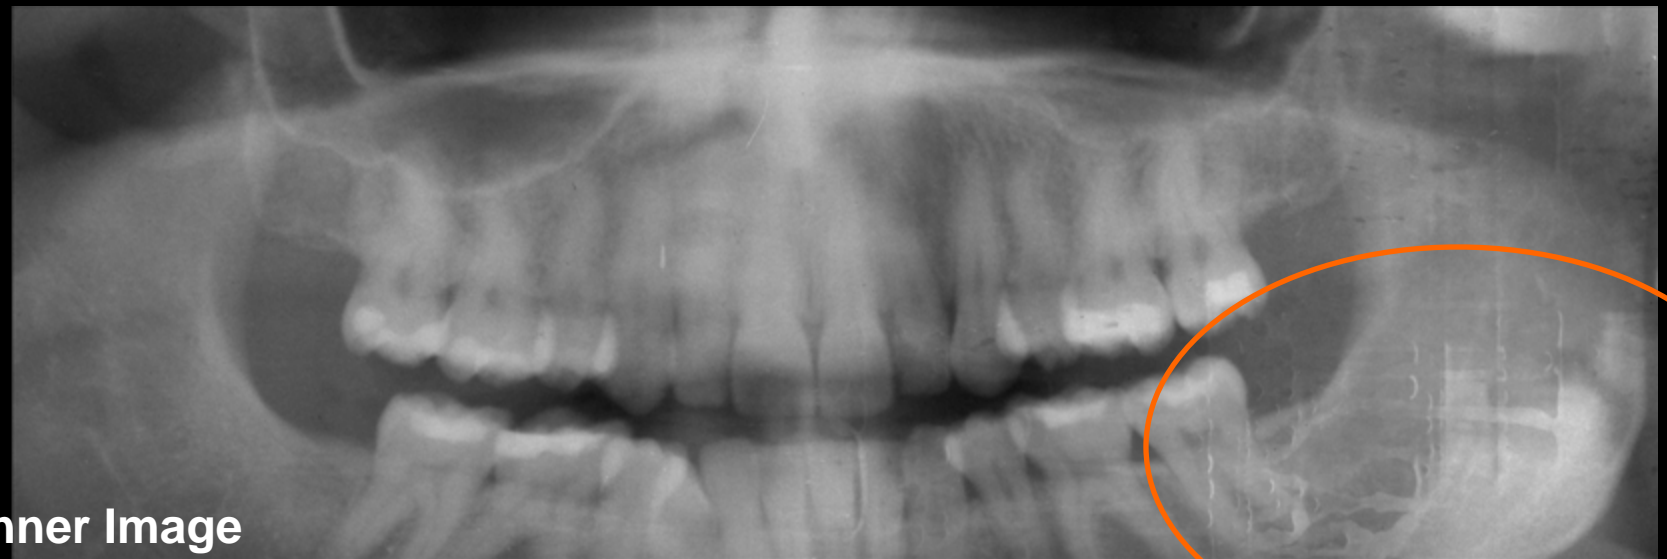
Photo on Lightbox

Artifacts from dirty roller show with scanner, VIDAR digitizer nearly eliminates markings.
